CIENEGA CREEK NATURAL PRESERVE

Hydrologic Monitoring & Analysis

July 2016 to June 2017

Prepared by
PIMA COUNTY REGIONAL FLOOD CONTROL DISTRICT
Water Resources Division
David Scalero Principal Hydrologist
Frank Postillion Chief Hydrologist
December 2017

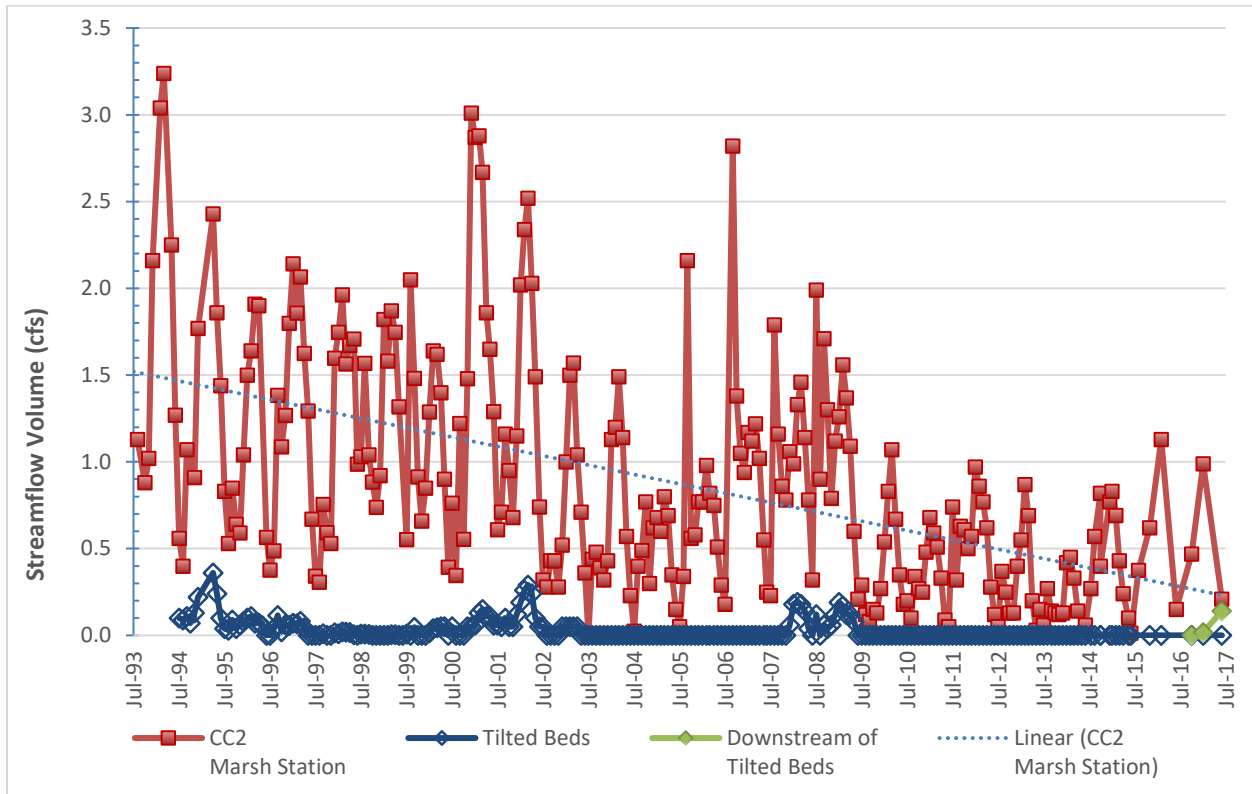
Figure 2-2. Monthly Streamflow Volume at Tilted Beds and Marsh Station Sites (1993-2017)

The overall flow trend along Cienega Creek has been downward since 1993, when regular monitoring within the Preserve began (**Figure 2-2**). The yearly seasonal pattern typically indicates the highest base level stream flows occur during the winter months (December through March) while the lowest level stream flows occur during the late spring (May through June). The lowest level recorded at Marsh Station Road was 0.013 cfs in June 2015. Peak base flows at this site have not reached over 2 cfs since September 2006 and over 1.5 cfs since February 2009. No flows have been observed or recorded at the Tilted Beds site since May 2009. Due to the recent dry trend, District staff started monitoring a site downstream of the Tilted Beds in October 2016 to obtain data for the most upstream extent of perennial flow within the Preserve.

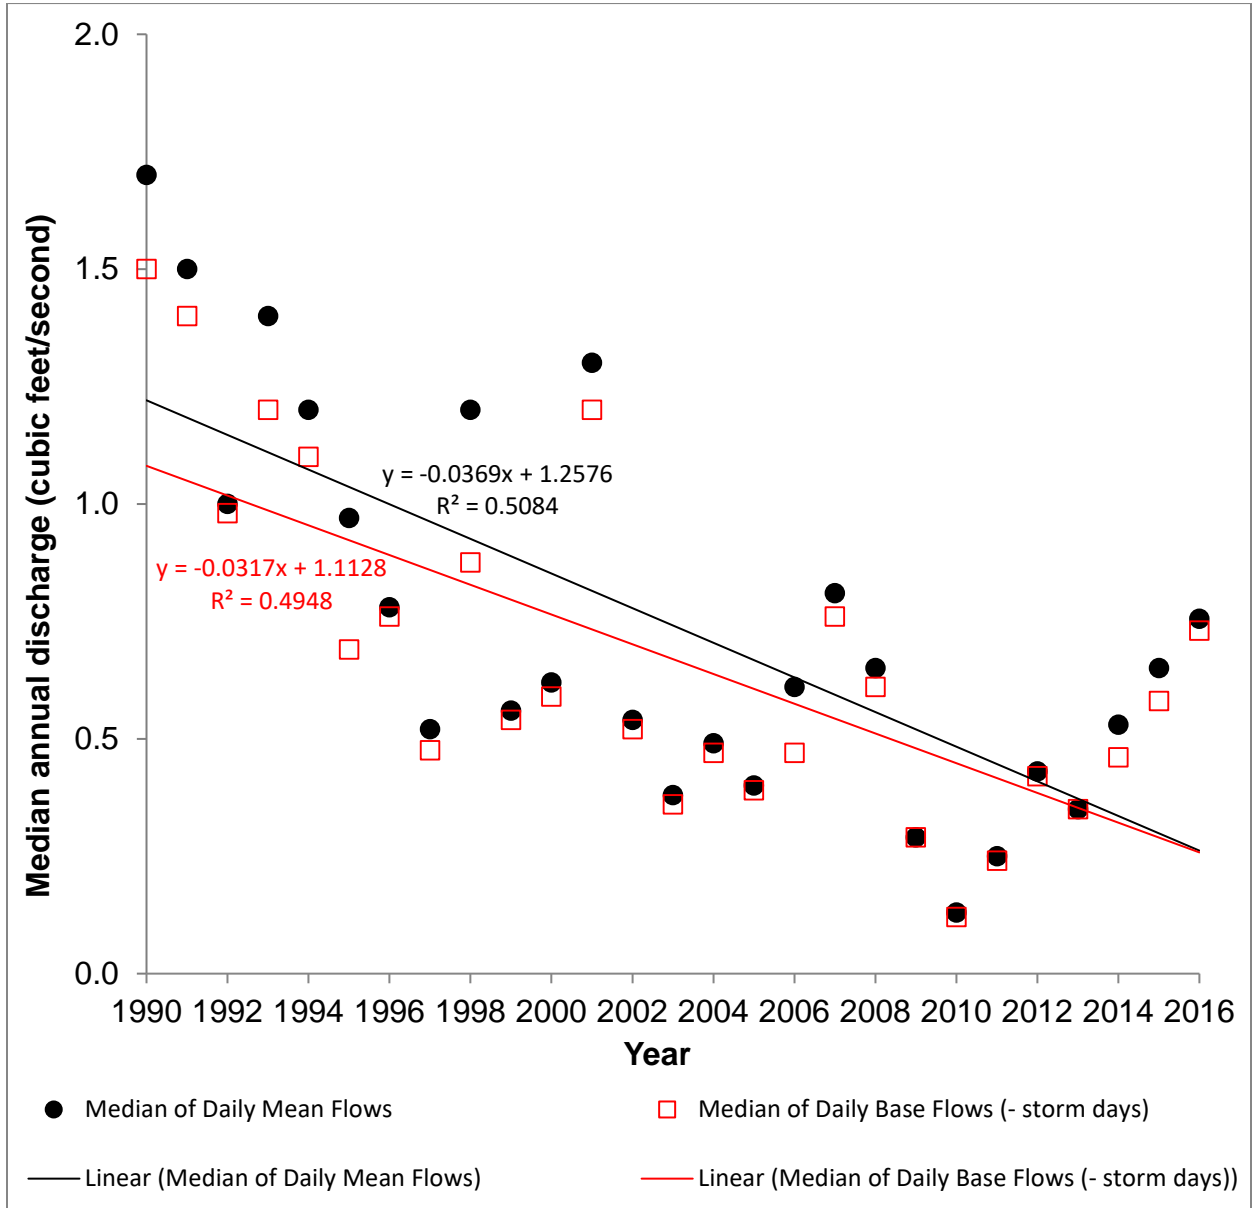
Figure 2-3. Base Flow Trends at Pantano Dam USGS Gage 09484600

Figure 2-3 shows the median base flow trends since 1990 for the USGS gage at Pantano Dam. The gage is at the downstream end of the Cienega Creek watershed and is an indicator of watershed health by showing the amount of daily water draining from the watershed. In 1990, the median daily flow was around 1.5 cfs. The trend has been steadily downward, reaching a low in 2010 of around 0.13 cfs. The recent recovery of median flows up to 0.75 cfs in 2016 has been encouraging, but may only be cyclic like 2006-2008.

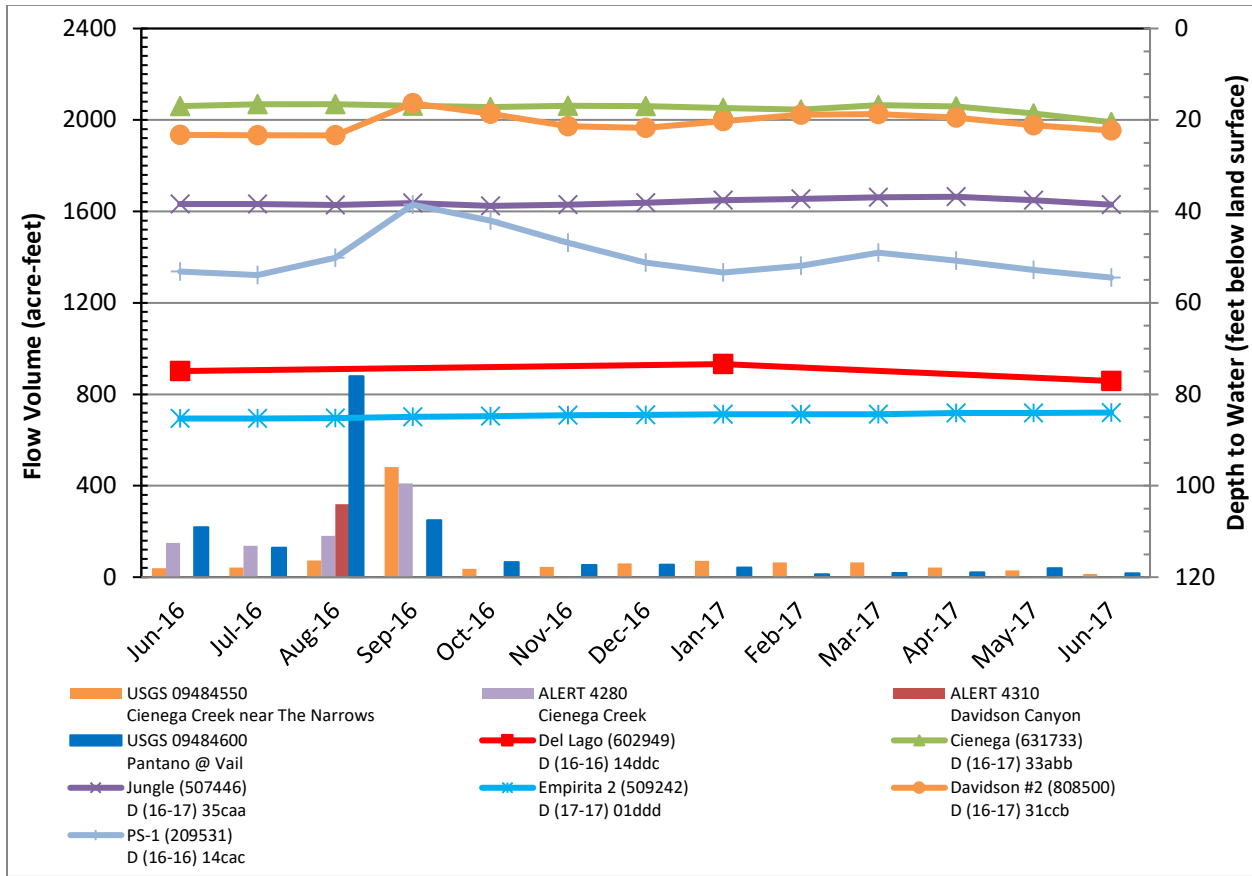
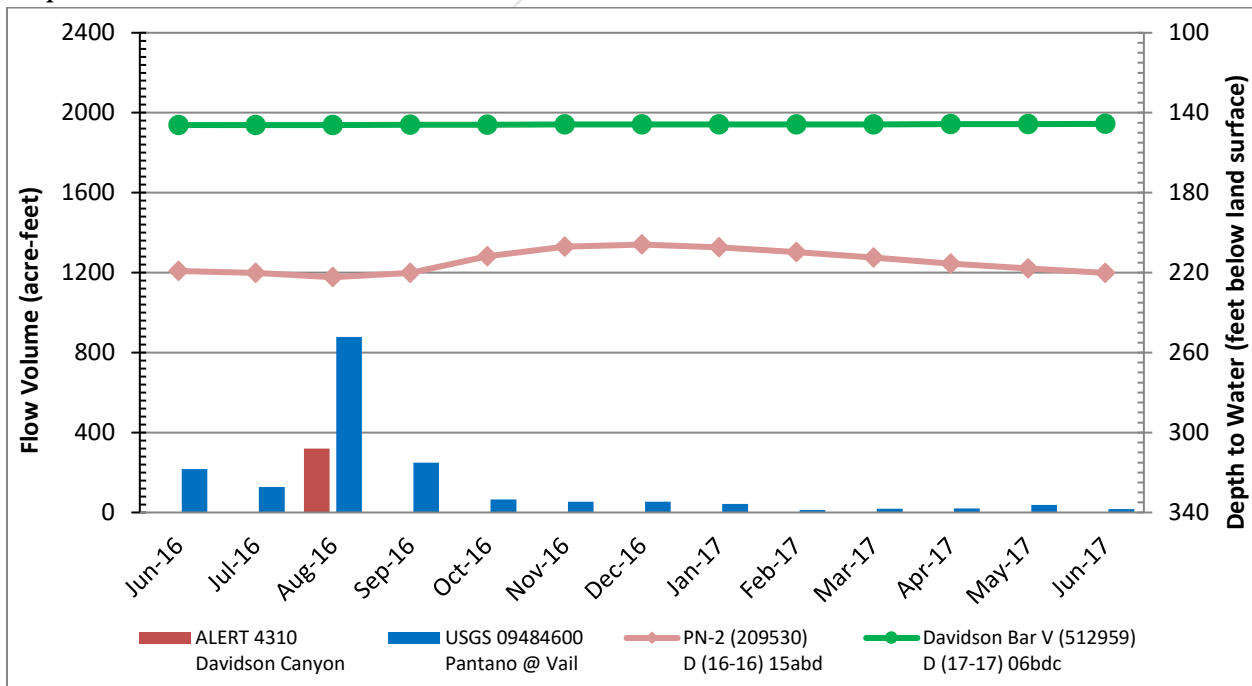
Figure 4-2. Monthly Flow Volumes vs. Groundwater Levels at Cienega Creek Natural Preserve, June 2016 - June 2017

Figure 4-2 displays groundwater levels in relation to stream flows from June 2016 to June 2017. Three of the wells (Davidson #2, PS-1 and PN-2) showed significant water level recoveries with the onset of summer monsoon runoff from August through September 2016. Despite flows recorded along Cienega Creek near I-10 (ALERT 4283), neither the Jungle nor Cienega Wells showed any rise in groundwater levels during this period. After a brief decline from October through December 2016, water levels in the shallow wells recovered slightly through March 2017 without any significant flow recorded in the area. The deep well near the downstream end of the Preserve (PN-2) declined about six feet from December 2016 to June 2017, while the deep well along Davidson Canyon Wash (Davidson Bar V) remained stable throughout the fiscal year.

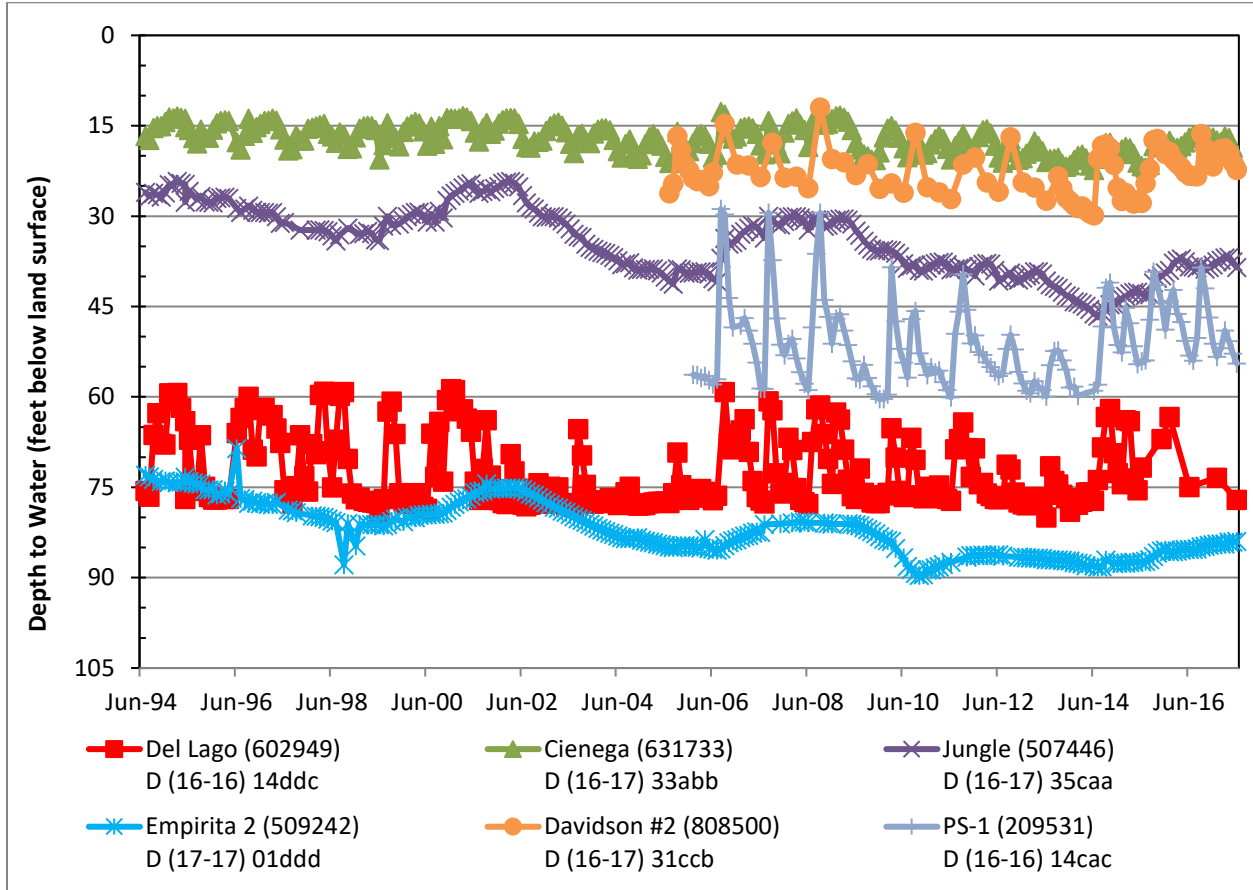
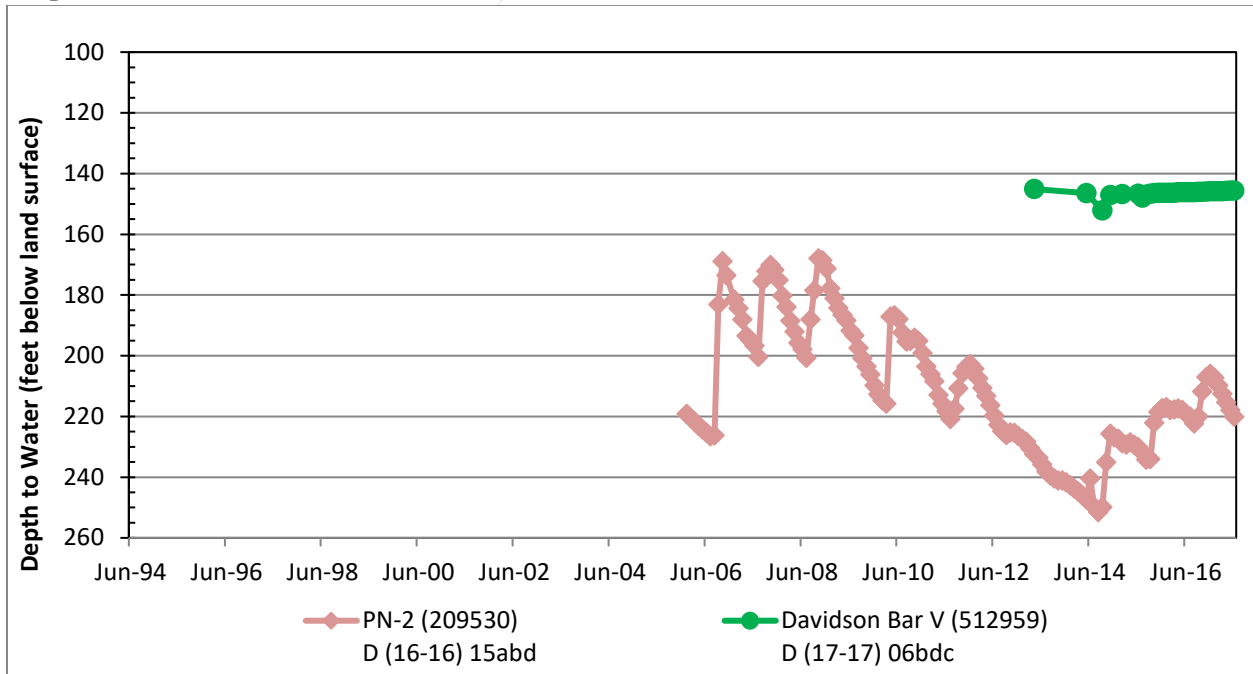
Figure 4-3. Monthly Groundwater Levels at Cienega Creek Natural Preserve, June 1994 - June 2017

With over twenty years of monitoring data available, a number of wells show a distinct seasonal trend in groundwater levels (**Figure 4-3**). Peaks typically occur during or just after the summer monsoon period (August and September) and lows near the end of spring (May and June). The annual rise and fall of groundwater levels, generally measured and reported in January when regional pumping is lowest, predominantly correlate with stream flow volume along Cienega Creek and Davidson Canyon Wash (**Figure 4-4**). Groundwater levels in the downstream wells appear to be more impacted by stream flow than those upstream. Reasons for this could be the lack of perennial flow due to surface water diversions by Del Lago Golf LLC at Pantano Dam, less vegetation along the stream banks to intercept groundwater, and the addition of flows from major tributaries such as Davidson Canyon Wash and Aqua Verde Creek that intersect Cienega Creek downstream of Cienega Well. Pumping from nearby municipal wells may also have an influence in the downstream area, especially at PN-2 Well, with recent recoveries attributed to a significant reduction in groundwater withdrawals in the area near Colossal Cave Road (**Figure 4-5**). The groundwater withdrawals displayed in **Figure 4-5** represent all pumping, exempt and non-exempt wells, within the Lower Cienega Creek Basin - starting at The Narrows and ending approximately 1.5 miles downstream of Colossal Cave Road Bridge.

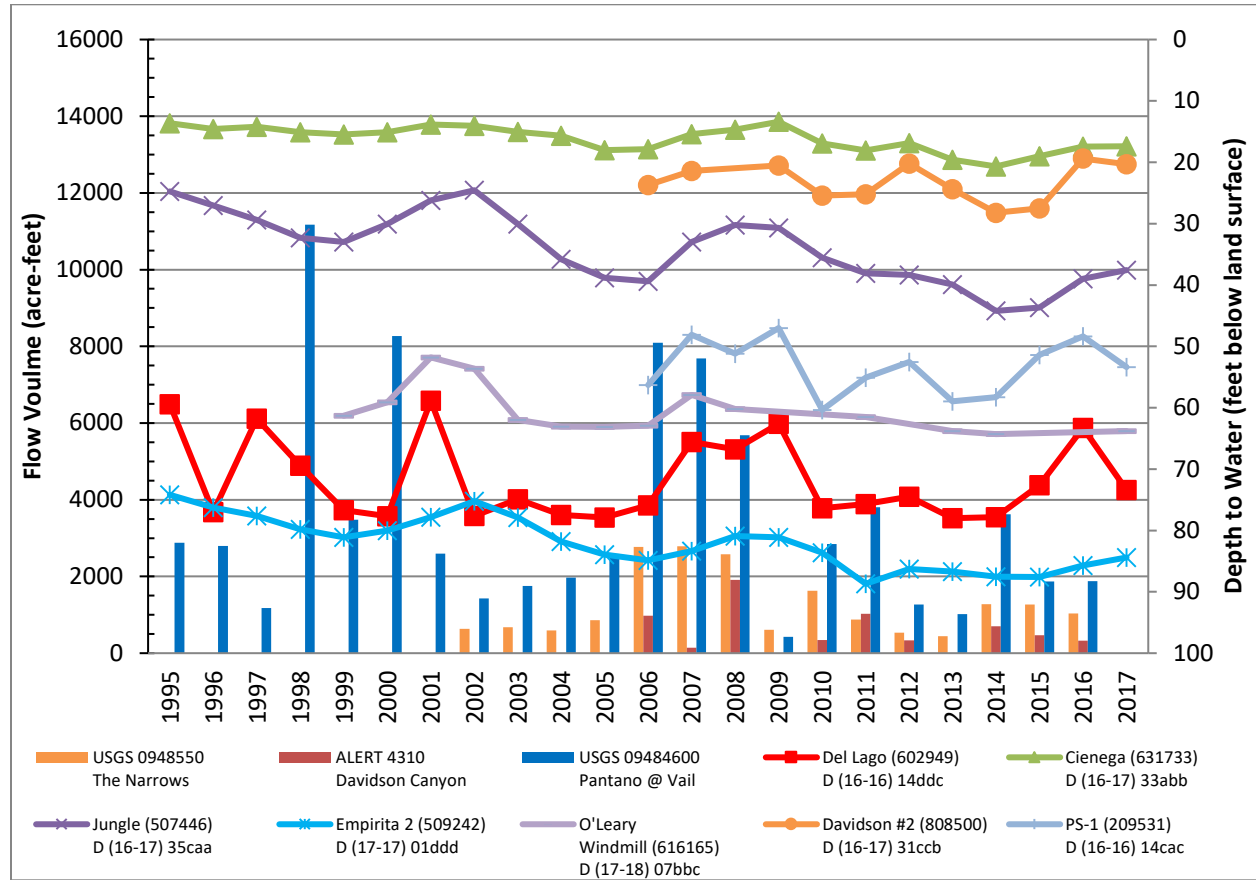
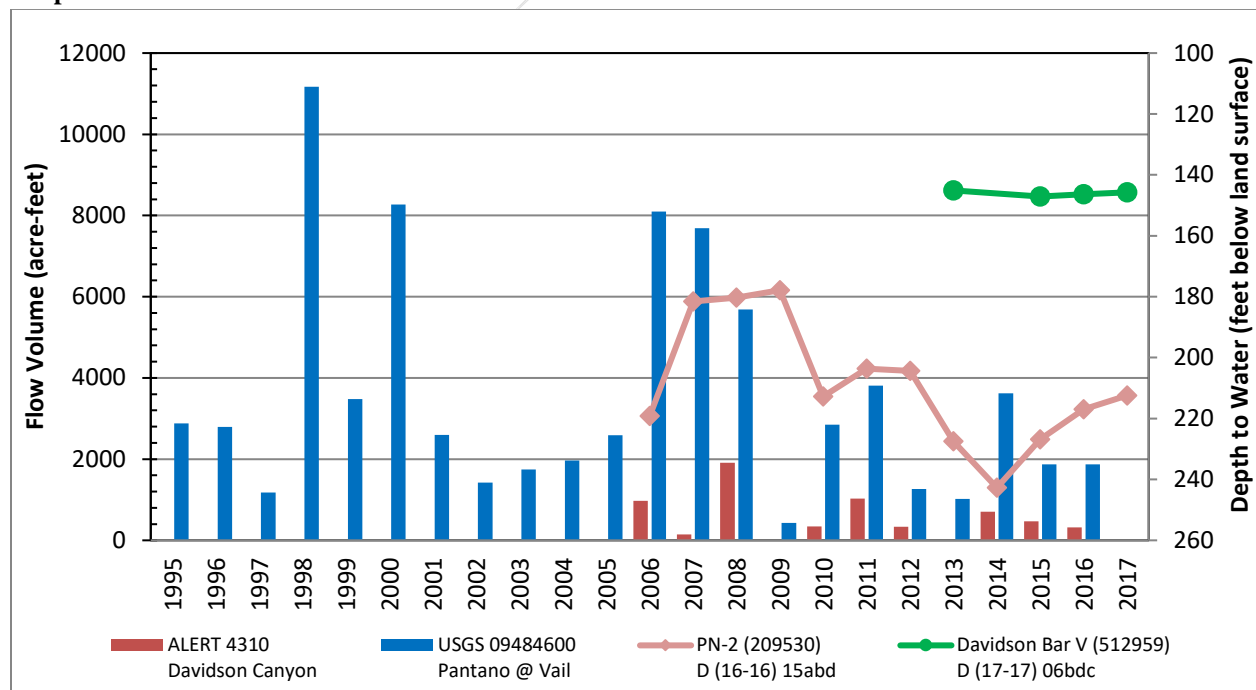
Figure 4-4. Annual Flow Volumes vs. Shallow Groundwater Levels at Cienega Creek Natural Preserve: 1995-2017

Groundwater levels within the Preserve have been trending downward since 1995, as depicted in in **Figure 4-4**, with an average annual rate of decline of 0.46 feet for four of the monitoring wells (**Table 4-2**). However, water levels have been recovering at an average rising rate of 0.24 feet per year since 2006, based upon seven monitoring wells. The average rate of recovery has been highly influenced by wells in the downstream area. The decline in water levels over the last year indicates that the most recent ten-year trend may only be temporary if drier conditions continue to prevail.

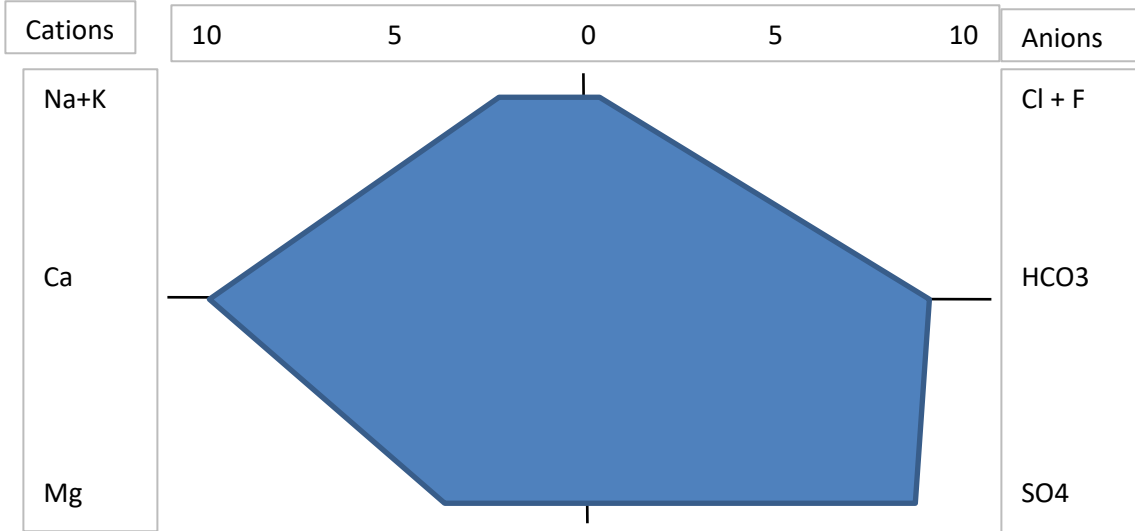
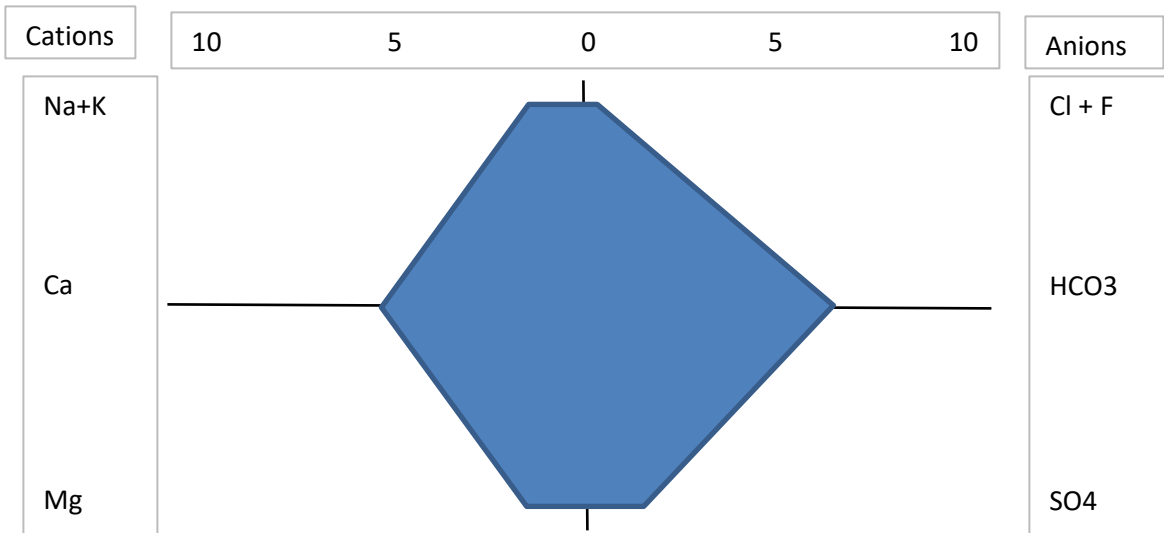
Figure 5-2. Stiff Diagrams for Cienega Creek and Davidson Canyon Wash (average results)

Water quality monitoring has been conducted semi-annually along Cienega Creek since 2010 and along Davidson Canyon Wash since 2008 to establish baseline conditions. The Davidson Canyon site was dry during a number of site visits, with no samples collected during Calendar Years 2011 and 2013. Similar to the most recent results, average water quality within the Preserve has been very good over the last seven to nine years with only the secondary drinking water standards of sulfate, total dissolved solids, and manganese being exceeded (**Table 5-2**). Based upon analyses of cations (calcium, magnesium, and sodium + potassium) and anions (sulfate, alkalinity and chloride + fluoride), the surface water along Cienega Creek can be classified as a calcium-sulfate bicarbonate type, while the surface water along Davidson Canyon Wash is more of a calcium bicarbonate type (**Figure 5-2**).

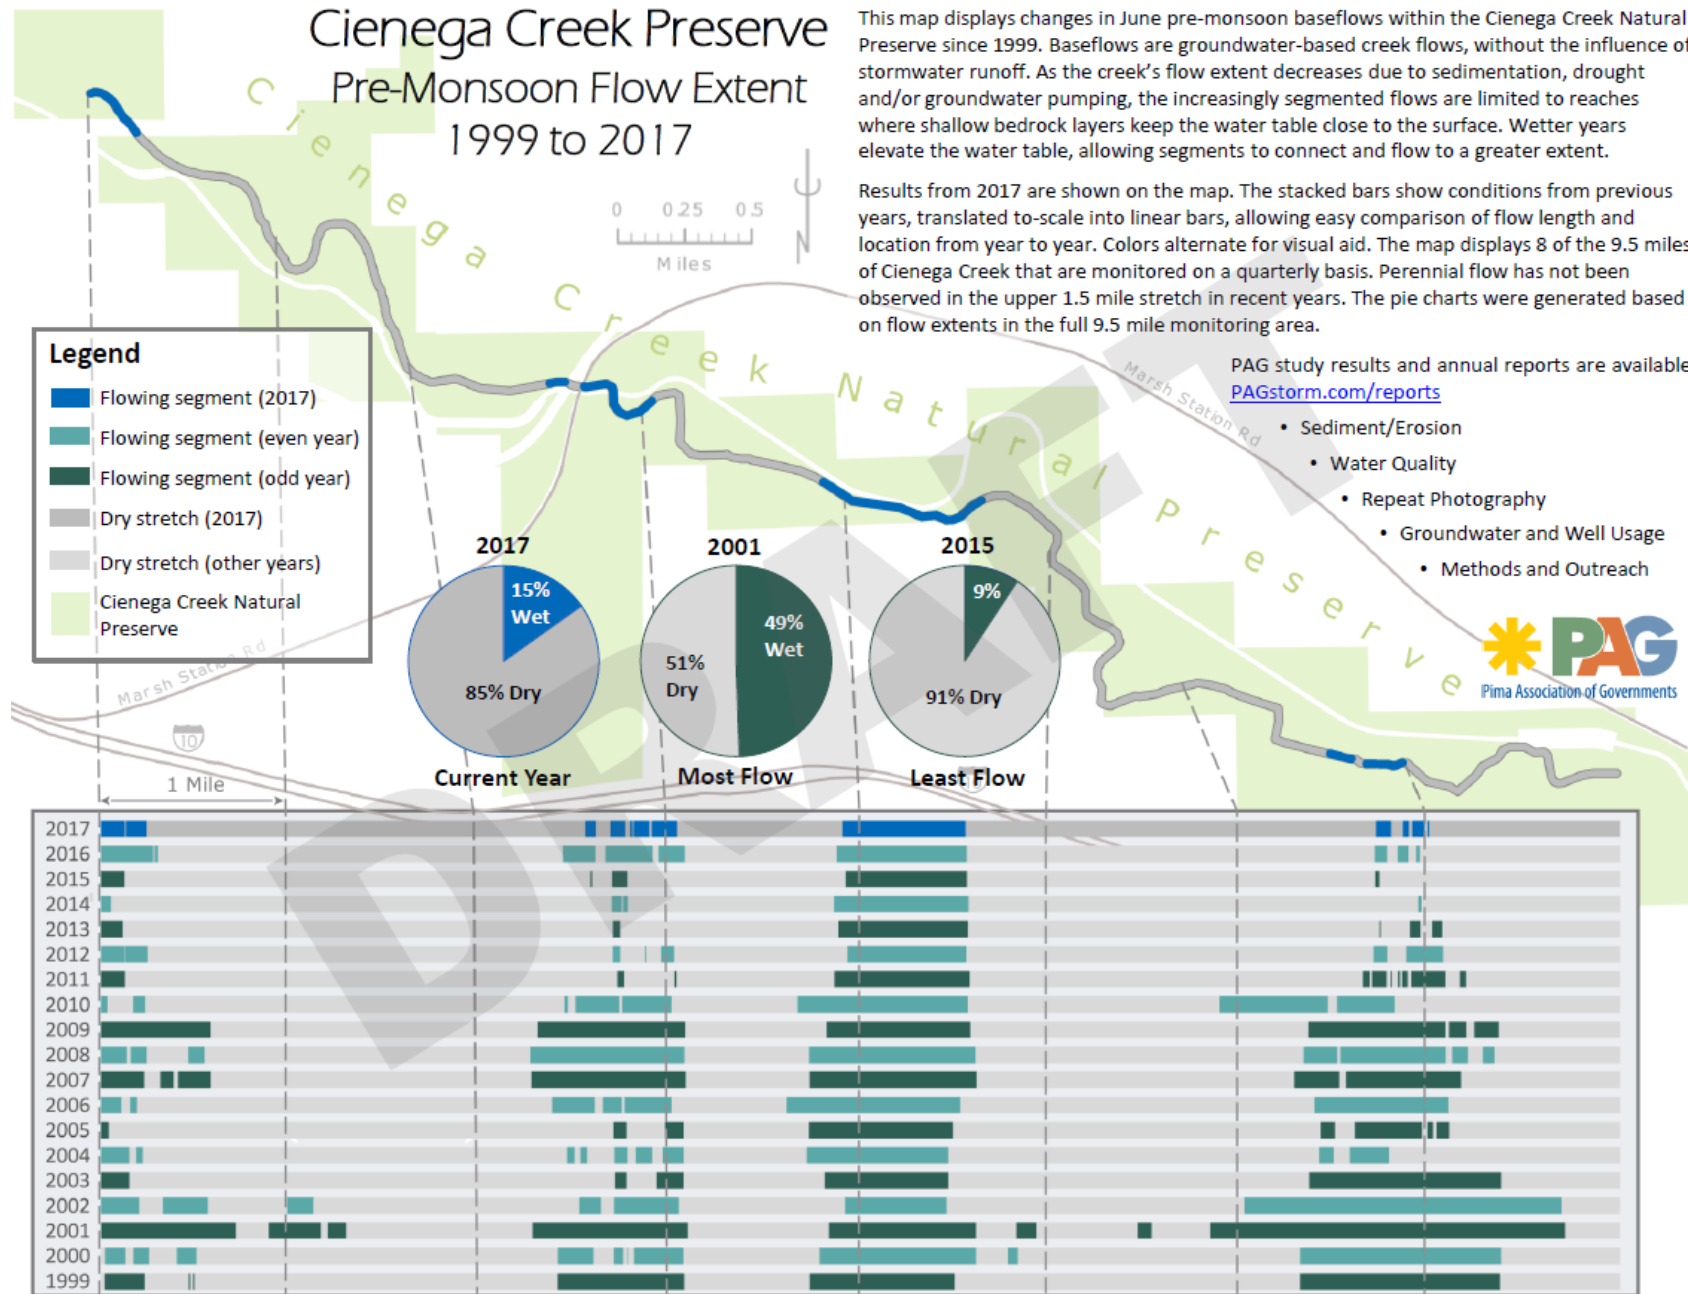
This map displays changes in June pre-monsoon baseflows within the Cienega Creek Natural Preserve since 1999. Baseflows are groundwater-based creek flows, without the influence of stormwater runoff. As the creek's flow extent decreases due to sedimentation, drought and/or groundwater pumping, the increasingly segmented flows are limited to reaches where shallow bedrock layers keep the water table close to the surface. Wetter years elevate the water table, allowing segments to connect and flow to a greater extent.

Results from 2017 are shown on the map. The stacked bars show conditions from previous years, translated to-scale into linear bars, allowing easy comparison of flow length and location from year to year. Colors alternate for visual aid. The map displays 8 of the 9.5 miles of Cienega Creek that are monitored on a quarterly basis. Perennial flow has not been observed in the upper 1.5 mile stretch in recent years. The pie charts were generated based on flow extents in the full 9.5 mile monitoring area.
