Riparian Health Assessment Summary

Monitoring Year 2020-21: Poor monsoon exacerbates drought conditions in the Cienega Creek watershed

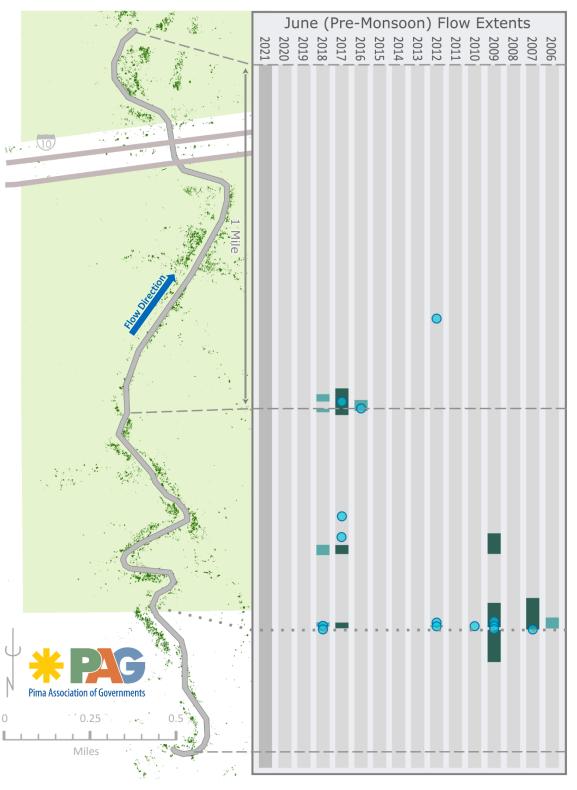
Upper Davidson Canyon Pre-Monsoon & Quarterly Flow Extents 2005 to 2021

The chart at left displays changes in June pre-monsoon baseflows for Davidson Canyon within the CCNP since 2006. Results from 2021 are shown on the map. The map displays just over two miles of upper Davidson Canyon, where intermittent flows have been observed since 2006. Tree canopy data and regular riparian health assessment data show that the riparian vegetation in Davidson Canyon has persisted over time, supported by shallow groundwater.

Davidson Canyon was dry upstream of Interstate 10 (I-10) all four quarters. This was the first monitoring year in which upper Davidson Canyon was dry on all monitoring dates. Flow extents in upper Davidson Canyon are highlighted on page 3.

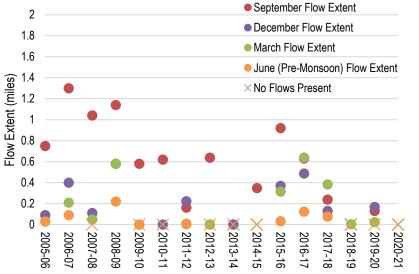
Davidson Canyon Quarterly Flow Extents

The graph below shows quarterly flow observations measured in September, December, March and June of each monitoring year. Flow extents include the total length of flow and isolated pools that are not adjacent to flow within this stretch of Davidson Canyon.

(Upstream of I-10)

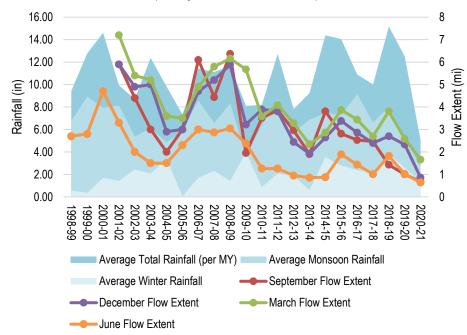
Average Rainfall vs. Cienega Creek Flow Extents

The graphs to the right show average monsoon, winter and total rainfall trends versus quarterly flow extents in Cienega Creek and upper Davidson Canyon. Average rainfall was calculated using historical rainfall data available from the Pima County Regional Flood Control District's Automated Local Evaluation in Real Time (ALERT) database. Rainfall totals were averaged from seven precipitation gages in the Cienega watershed (numbers 4250, 4270, 4280, 4290, 4310, 4320, and 4410). Gage locations are shown on the map below, along with washes that drain to Cienega Creek and Davidson Canyon. Rainfall averages were calculated for the following time periods within each monitoring year: monsoon (June 15 – Sept. 30), winter (Dec. 1 – Feb. 28/29) and monitoring year (July 1 – June 30). While the monitoring year runs from July 1 to June 30, June 15 was used for monsoon totals, as the monsoon season officially begins on June 15.

(Cienega Creek Natural Preserve)

Since 1998, flow extents have trended downward in Cienega Creek across all quarters, while rainfall has fluctuated from year to year. Flow extents in upper Davidson Canyon reflect a similar trend since 2005. Southern Arizona has experienced drought since the mid-1990s. These data suggest that precipitation and resulting groundwater recharge has not been sufficient during the drought to balance out both natural and human demands on the shallow groundwater that feeds this system. As drought conditions and groundwater pumping continue, flows will likely continue to decline.

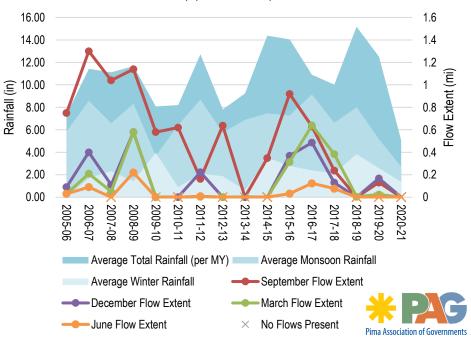
Average Rainfall vs. Upper Davidson Canyon Flow Extents

(Upstream of I-10)
