## **Riparian Health Assessment Summary**

# Monitoring Year 2022-23: Natural groundwater recharge continues to sustain strong flows in Cienega Creek

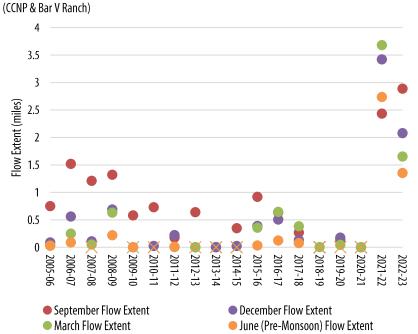
### **Davidson Canyon Quarterly Flow Extents**

- Davidson OAW Upstream Limit

Cienega Creek Natural Preserve

Pima County's Bar V Ranch

× No Flows Present
